Re: Notification of Closure by Removal - City of Columbia Water & Light Department
Inactive CCR Surface Impoundment (More's Lake)

This letter report, prepared by Burns & McDonnell on behalf of the City of Columbia (City), provides notification of closure by removal of CCR material, a summary documentation of the CCR removal activities, and groundwater monitoring data.

Client: City of Columbia
Project Location: More's Lake, Columbia, Missouri
Project Number: 93647
Report: CCR Removal

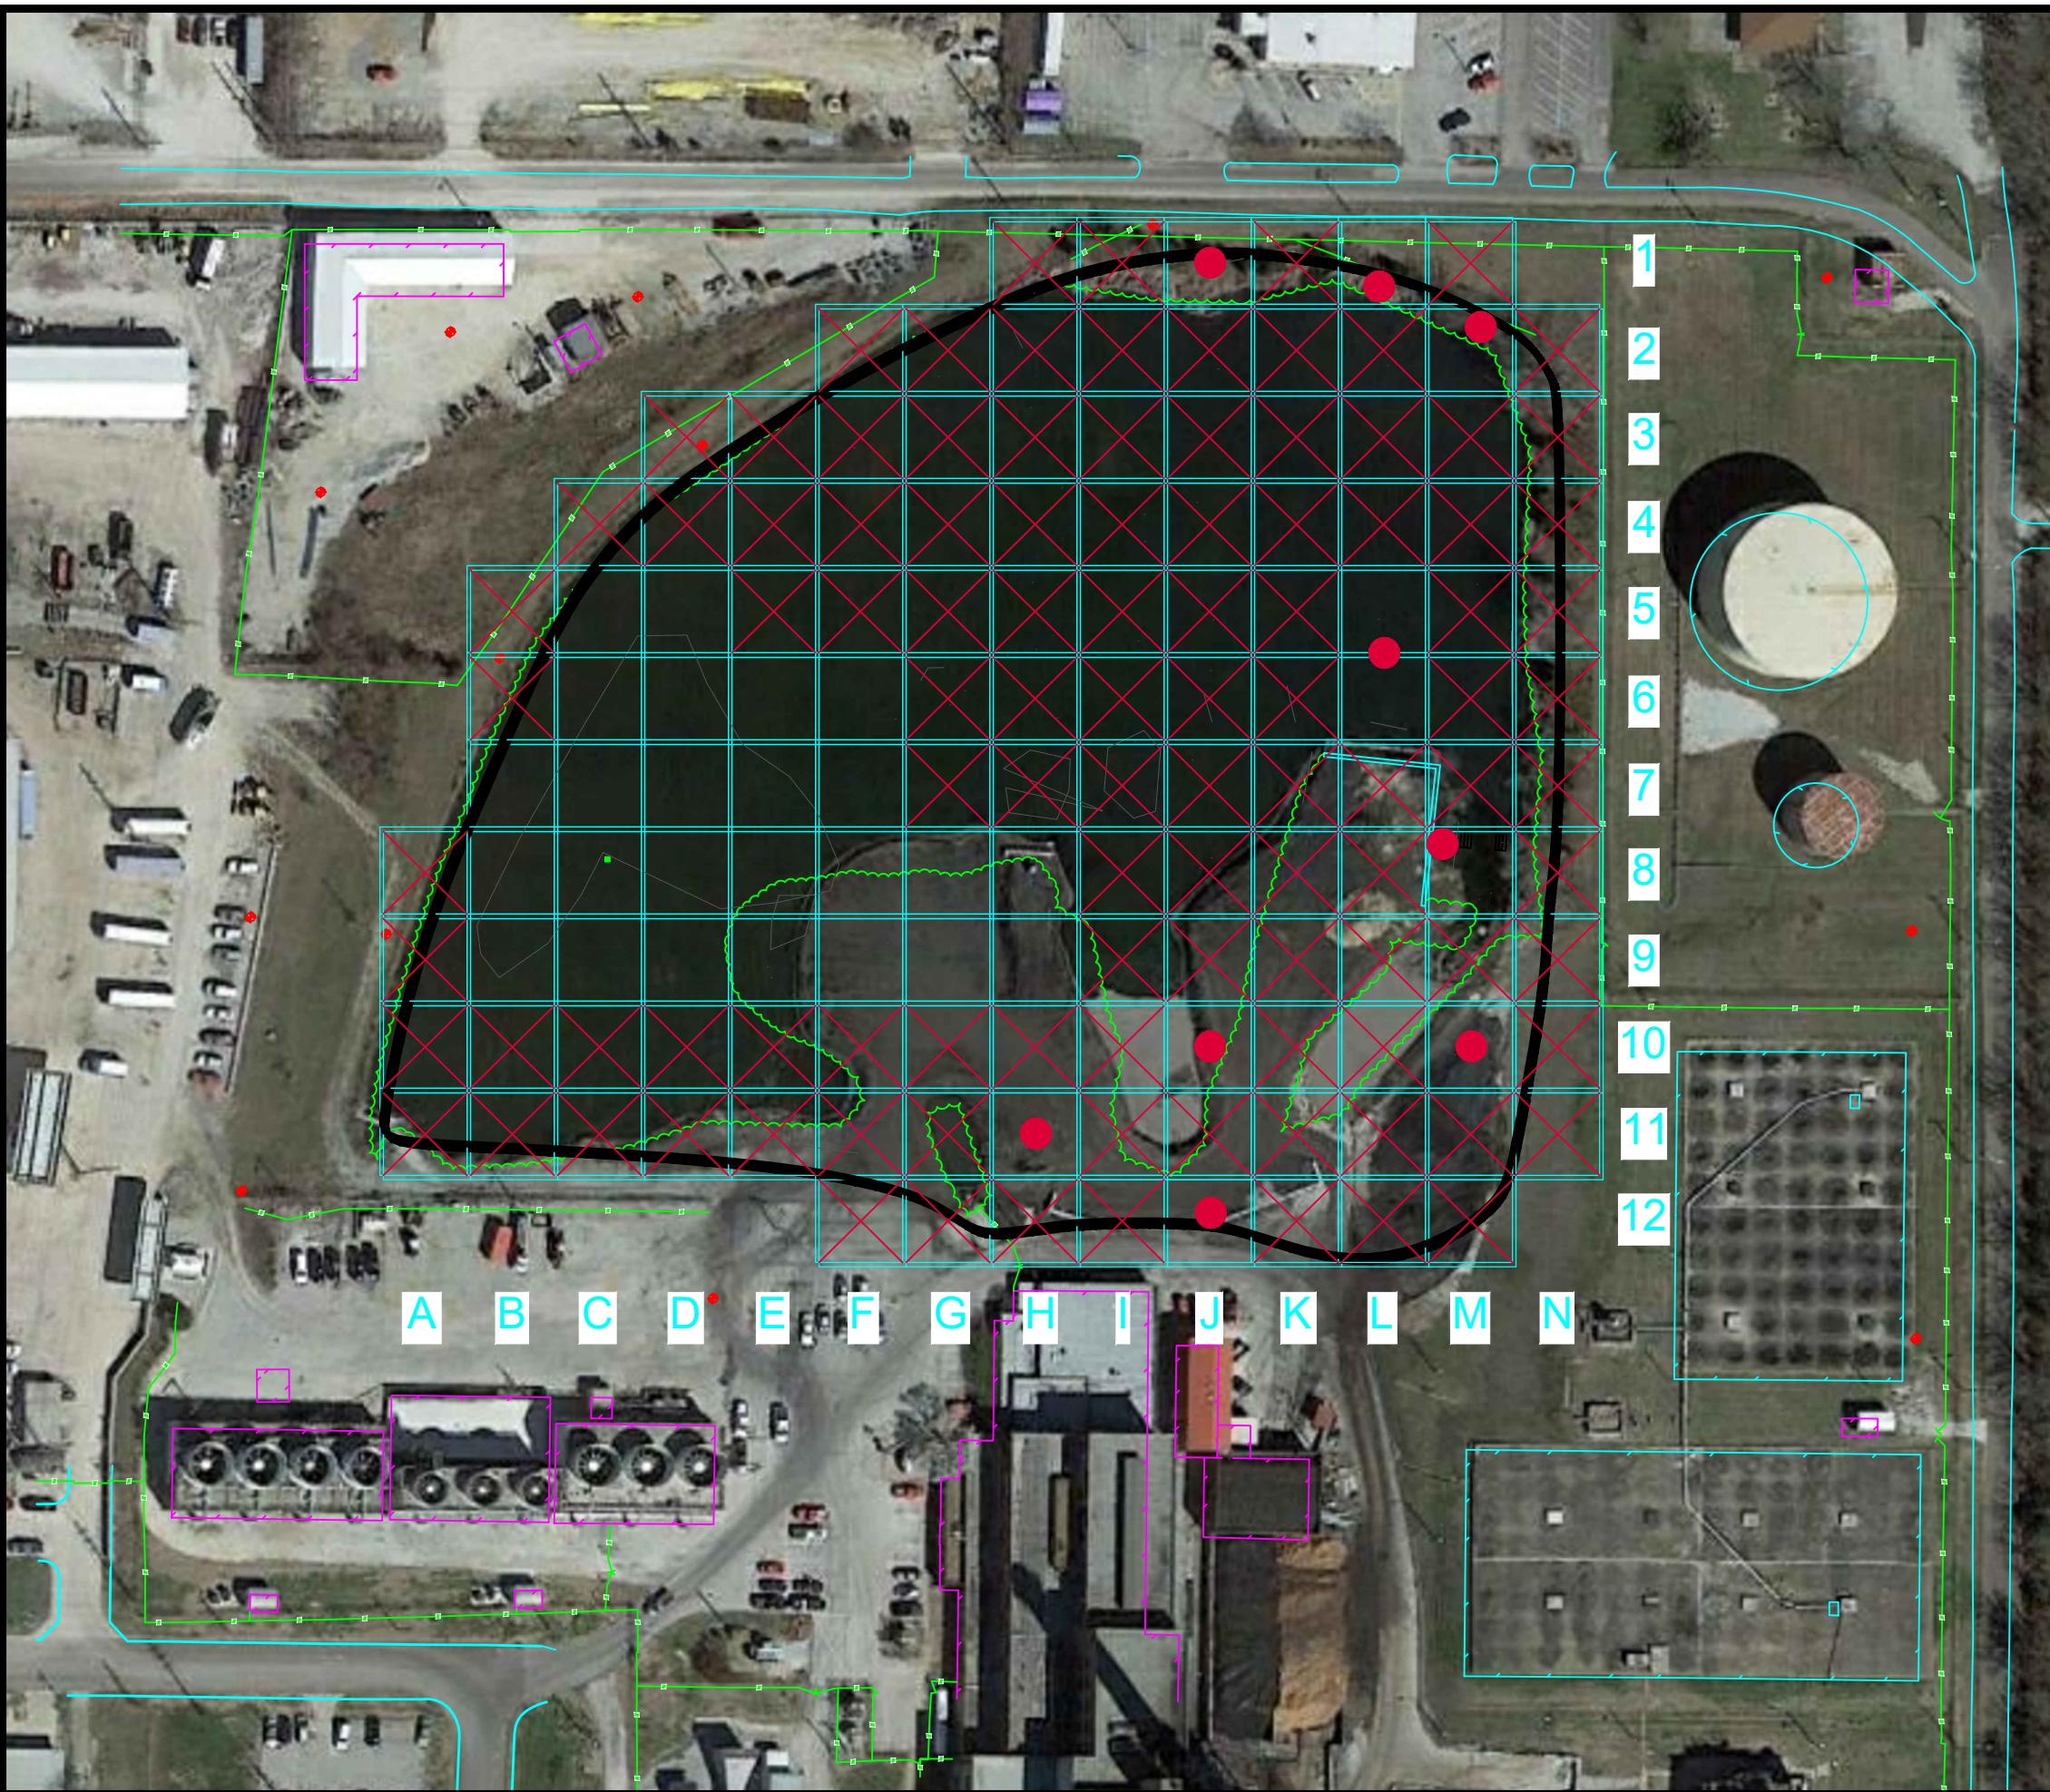
FIGURE 1
MAY 14, 2019
VISUAL INSPECTION GRID
COLUMBIA MUNICIPAL POWER
PLANT
COLUMBIA, MISSOURI

In the winter and spring of 2019, the City continued removal of residual CCR in the identified locations as well as in other areas previously stockpiled or submerged under water in the ponded sump area. In May of 2019, the City contacted Burns & McDonnell to resume the CCR removal verification inspections. Due to the extended time and work completed since the previous inspections, Burns & McDonnell approached the 2019 inspections assuming no grids had been previously cleared. The first inspection of 2019 took place on May 14, 2019. The same procedure was performed as described above with visually identified CCR flagged in the field and logged on the grid map. Nine relatively small, isolated locations were flagged during this inspection and several grids were submerged under the ponded water surface. Following this inspection, an updated map figure was provided to the City, showing the isolated locations where visual CCR remained and the submerged grids that were not inspected. This figure is provided in Attachment 1 (Figure 1). The next inspection took place on May 30, 2019, during which final CCR residual material locations were flagged in the field for removal. The City completed the removal of the CCR material at the identified areas over the next day. On May 31st the final inspection was made to verify all CCR material flagged the previous day had been visually removed. Figure 2 in Attachment 1 reflects the final inspection completed on May 31, 2019 with all grids cleared.

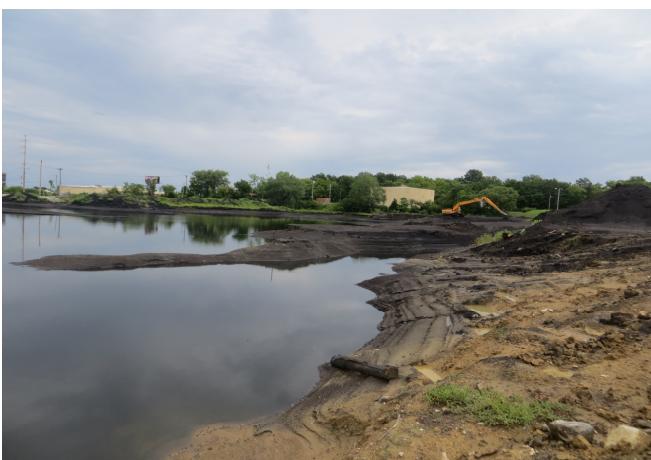
Photo # 1

| Photo No. | Date Taken | Description | Status |
|---|---|---|---|
| 1 | 8/2/2016 | SW corner of pond looking E | Prior to Removal Activities |

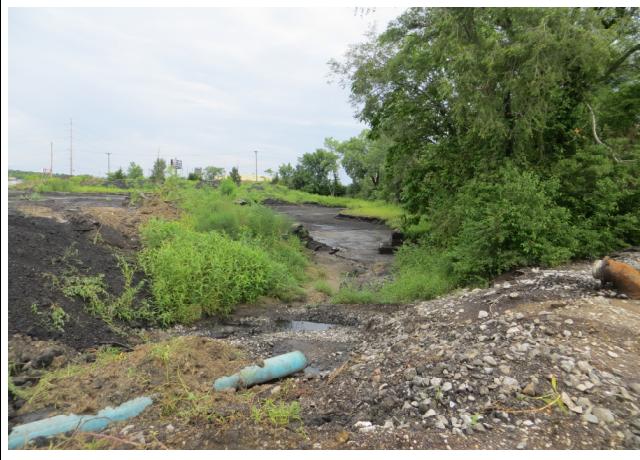
Photo # 2

| Photo No. | Date Taken | Description | Status |
|---|---|---|---|
| 2 | 8/2/2016 | Brush area | Prior to Removal Activities |

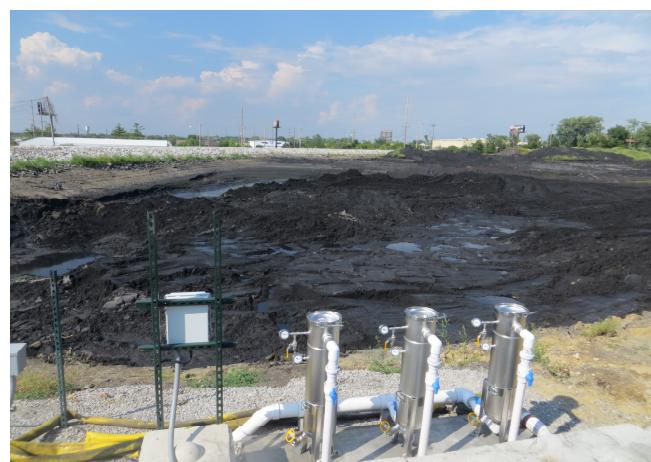
Photo # 3

| Photo No. | Date Taken | Description | Status |
|---|---|---|---|
| 3 | 8/29/2016 | SW corner of pond looking N | Prior to Removal Activities |

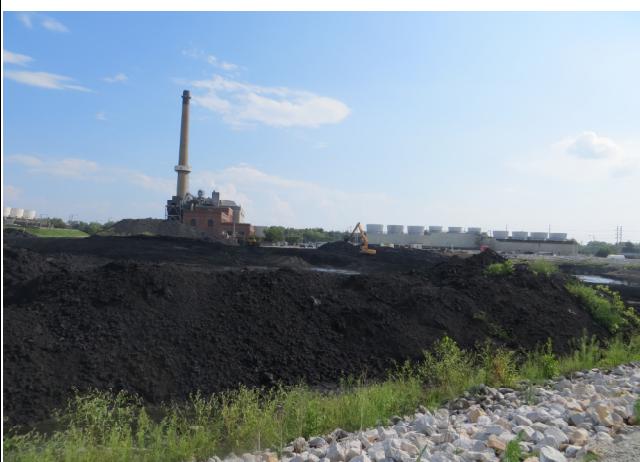
Photo # 4

| Photo No. | Date Taken | Description | Status |
|---|---|---|---|
| 4 | 8/29/2016 | W side of pond looking SE | Prior to Removal Activities |

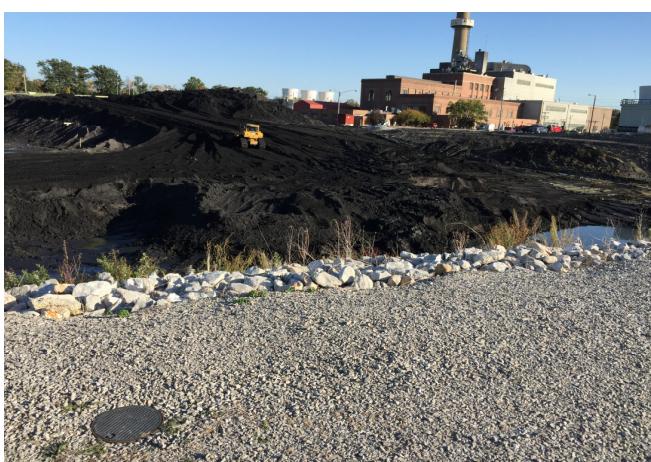
Photo # 5

| Photo No. | Date Taken | Description | Status |
|---|---|---|---|
| 5 | 10/18/2016 | W side of pond looking SE | Prior to Removal Activities |

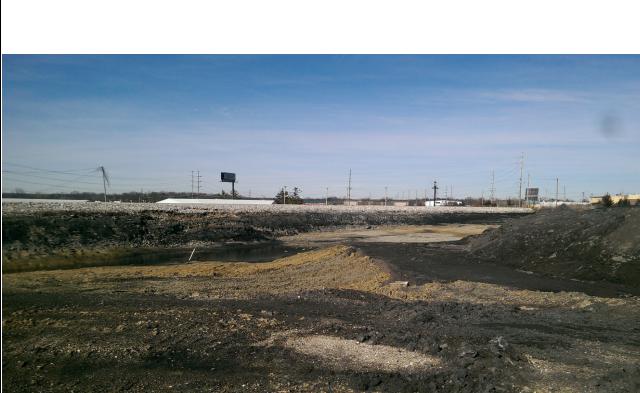
Photo # 6

| Photo No. | Date Taken | Description | Status |
|---|---|---|---|
| 6 | 2/3/2017 | S looking N | Cleanup Process |

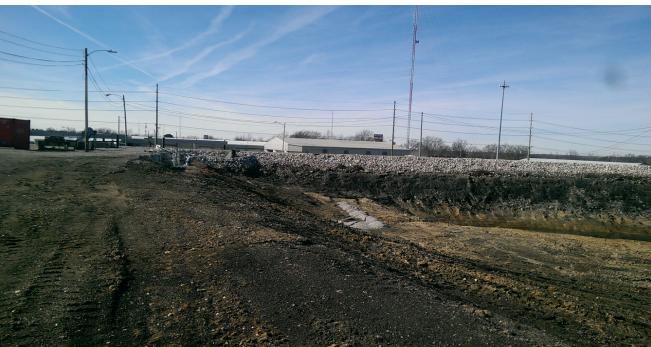
Photo # 7

| Photo No. | Date Taken | Description | Status |
|---|---|---|---|
| 7 | 2/3/2017 | S looking W | Cleanup Process |

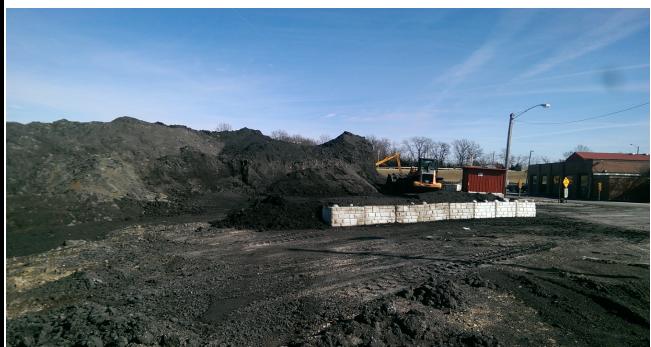
Photo # 8

| Photo No. | Date Taken | Description | Status |
|---|---|---|---|
| 8 | 2/3/2017 | S looking E | Cleanup Process |

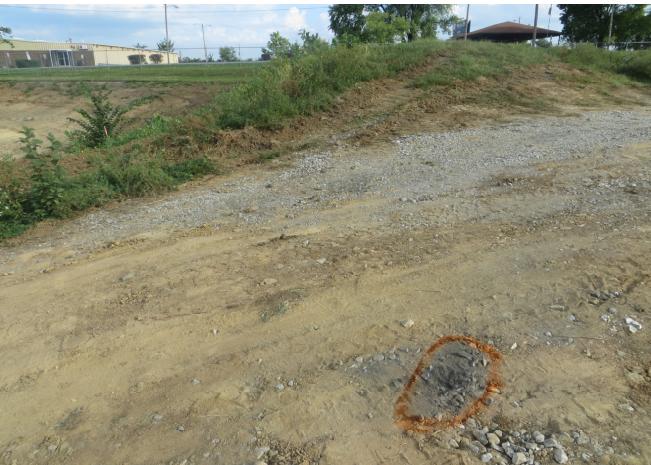
Photo # 9

| Photo No. | Date Taken | Description | Status |
|---|---|---|---|
| 9 | 9/19/2018 | Spot outlined to be removed | Initial Visual Inspection/Cleanup |

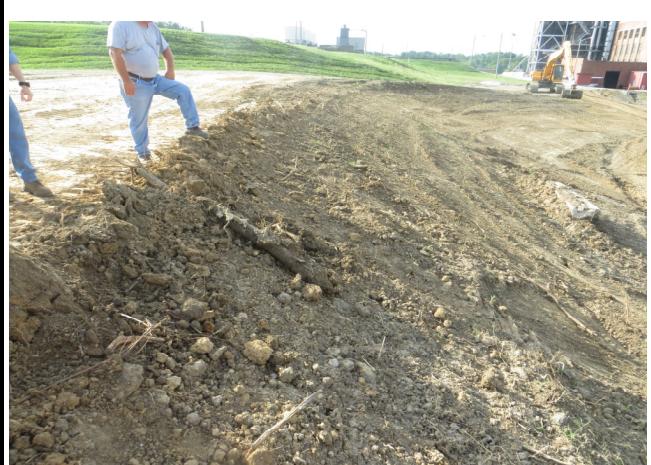
Photo # 10

| Photo No. | Date Taken | Description | Status |
|---|---|---|---|
| 10 | 9/19/2018 | Road area during inspection | Initial Visual Inspection/Cleanup |

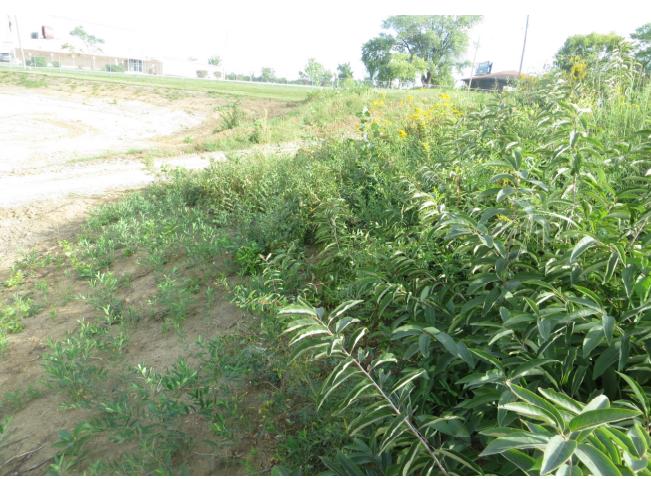
Photo # 11

| Photo No. | Date Taken | Description | Status |
|---|---|---|---|
| 11 | 9/19/2018 | Brush area | Initial Visual Inspection |

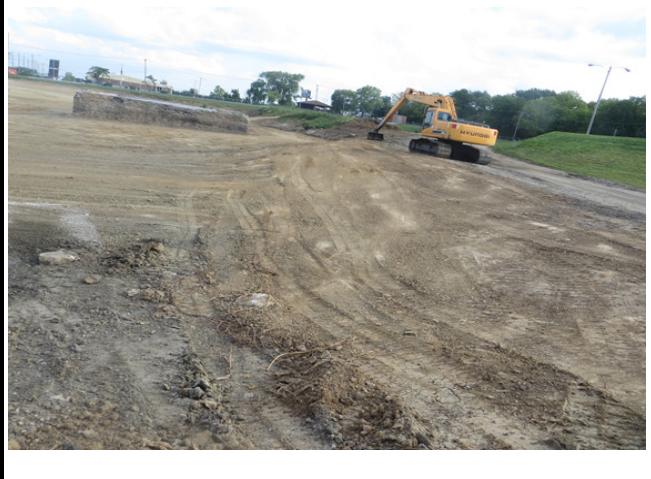
Photo # 12

| Photo No. | Date Taken | Description | Status |
|---|---|---|---|
| 12 | 9/19/2018 | Initial Visual Inspection SE looking N | Initial Visual Inspection |

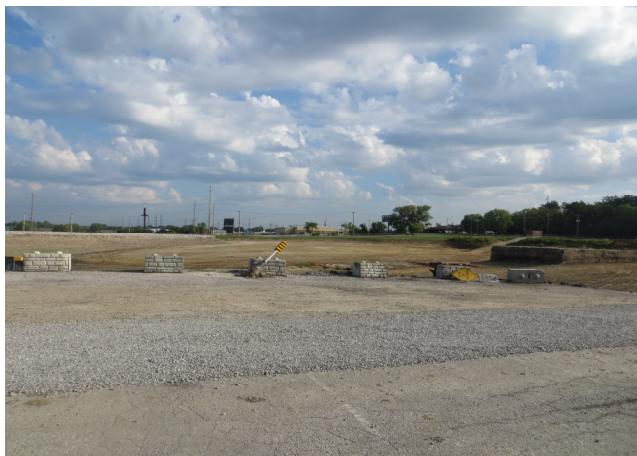
Photo # 13

| Photo No. | Date Taken | Description | Status |
|---|---|---|---|
| 13 | 9/19/2018 | Initial Visual Inspection S looking N | Initial Visual Inspection |

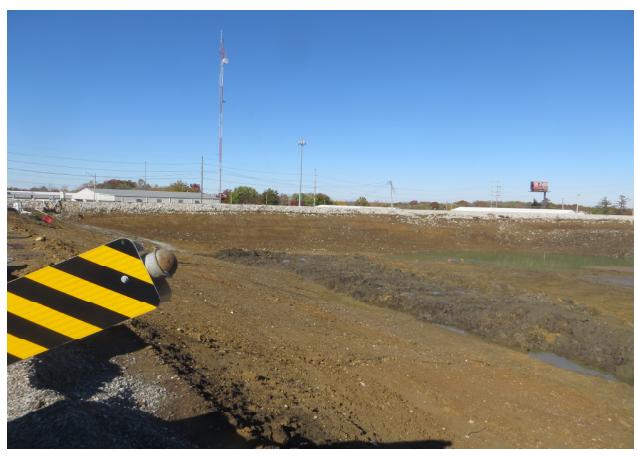
Photo # 14

| Photo No. | Date Taken | Description | Status |
|---|---|---|---|
| 14 | 11/6/2018 | S looking NW | Follow-up Visual Inspection |

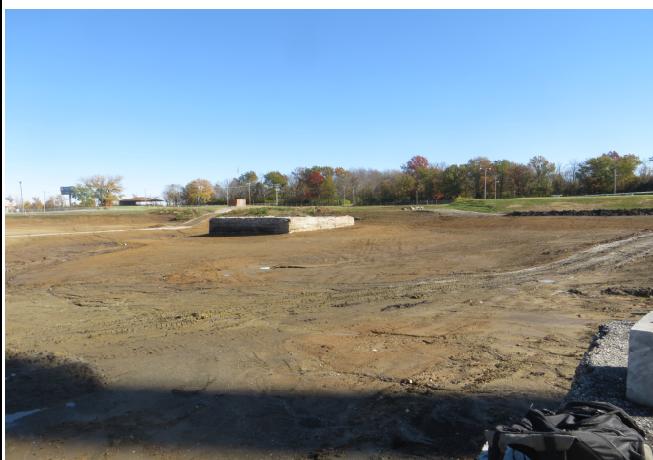
Photo # 15

| Photo No. | Date Taken | Description | Status |
|---|---|---|---|
| 15 | 11/6/2018 | S looking NE | Follow-up Visual Inspection |

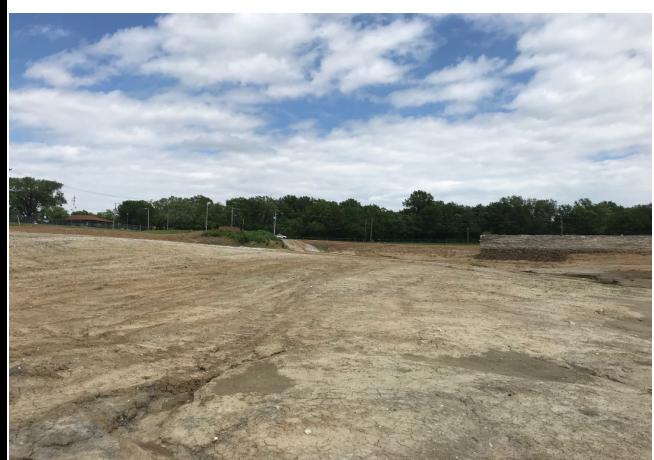
Photo # 16

| Photo No. | Date Taken | Description | Status |
|---|---|---|---|
| 16 | 5/31/2019 | Final Visual Inspection W looking E | Final Visual Inspection |

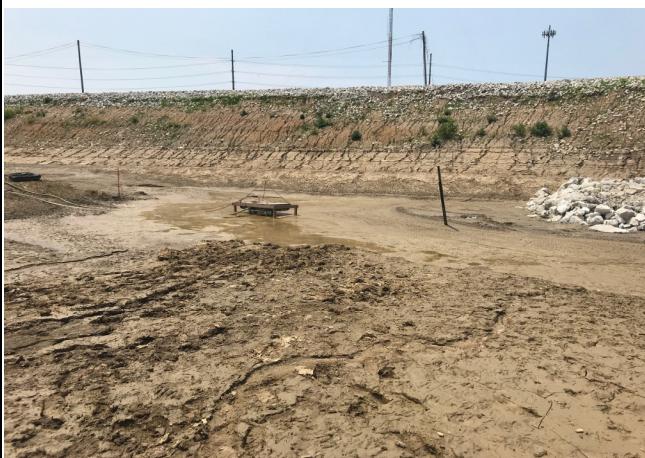
Photo # 17

| Photo No. | Date Taken | Description | Status |
|---|---|---|---|
| 17 | 5/31/2019 | Final Visual Inspection middle looking SE | Final Visual Inspection |

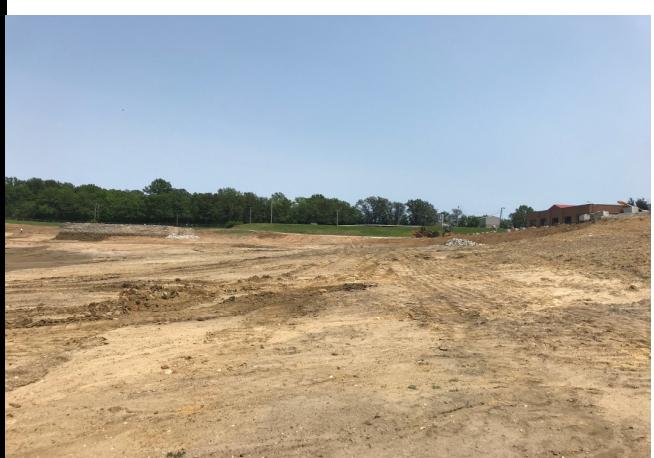
Photo # 18

| Photo No. | Date Taken | Description | Status |
|---|---|---|---|
| 18 | 5/31/2019 | Final Visual Inspection W looking E | Final Visual Inspection |
